DEPARTMENT OF TRANSPORTATION

Contract #: 04-0120F4Cty: SF/ALA Rte: 80 PM: 13.2/13.9File #: 69.28**WELDING INSPECTION REPORT****Resident Engineer:**Siegenthaler, Peter**Address:** 333 Burma Road**City:** Oakland, CA 94607**Report No:** WIR-023306**Date Inspected:** 13-Apr-2011**Project Name:** SAS Superstructure**OSM Arrival Time:** 1500**Prime Contractor:** American Bridge/Fluor Enterprises, a JV**OSM Departure Time:** 300**Contractor:** Zhenhua Port Machinery Company, Ltd (ZPMC), Changxing Island **Location:** Shanghai, China

Bridge No: 34-0006**Component:** OBG Segment Assembly**Summary of Items Observed:**

OBG Segment 14E / Bay 14

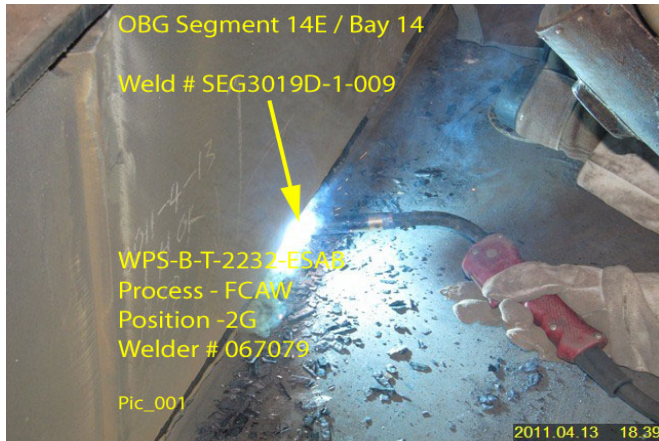
Shielded Metal Arc Welding (SMAW) in the 1G position of weld # SEG3019*-007. The welder is identified as 044779, 043661 and 0580872. Quality Control (QC) is identified as Wang Xu. The welding variables recorded by QC appeared to comply with WPS-B-P-2211-B-U2-FCM-1. See attached photograph Pic_001.

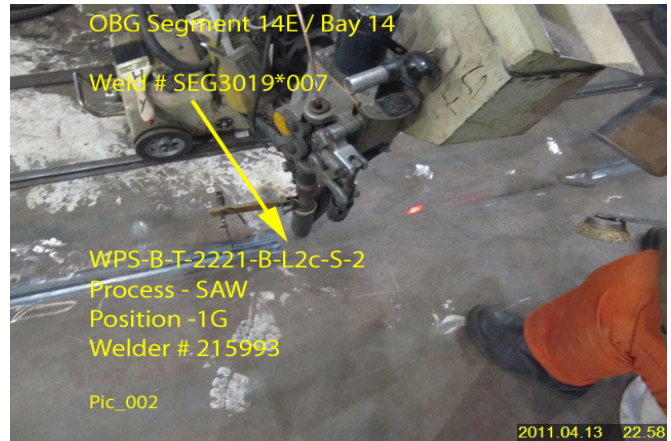
Sub Arc Welding (SAW) in the 1G position of Deck Panel weld # SEG3019-007. The welder is identified as 215993. Quality Control (QC) is identified as Xie Ming Feng. The welding variables recorded by QC appeared to comply with WPS-B-T-2221-B-L2c-S-2. See attached photograph Pic_002.
